Interferences

Issues after RBI connection to AiM CAN network

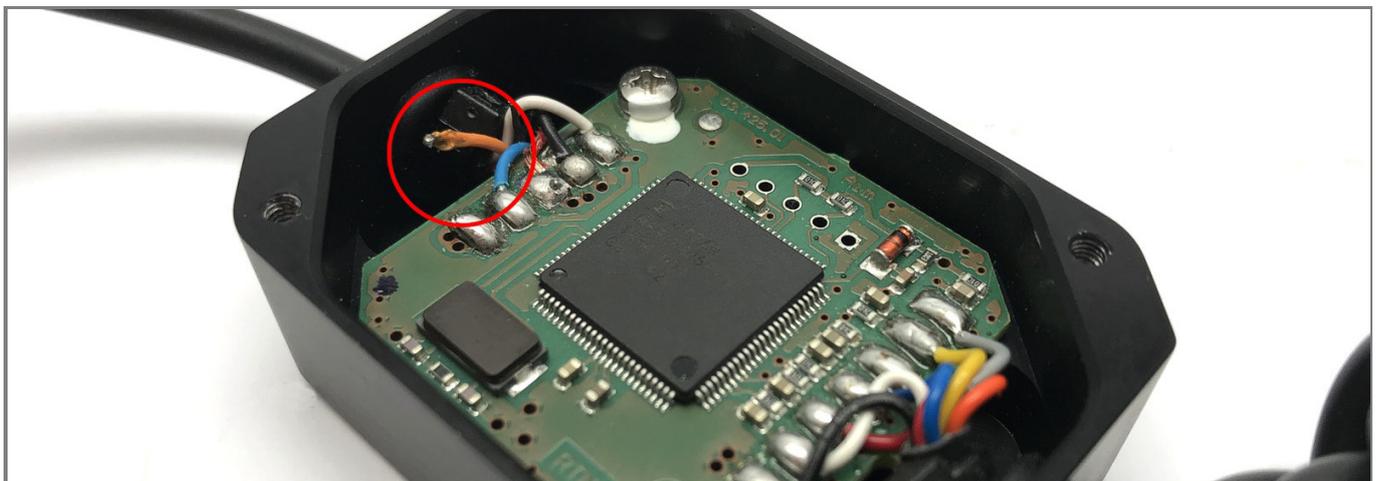
The issue previously occurred when RBI Module was connected to AiM CAN network since it caused a voltage comeback that did not allow the network to switch off, making thus impossible the network reset and the following identification process.

- unscrew the RBI top cover and remove it
- this way you have access to the internal board that shows wires weld on both sides: wires that go to the 5 pins male Binder connector and free wires you can connect to the buttons
- among the wires going to the Binder connector cut the orange one (Vbext – this is the one that causes the voltage comeback) paying attention that it does not come in contact with the welding places (image below).
- replace the top cover, screw it and reconnect RBI to the AiM CAN network.
